August 29, 2017

Removal of Tubing Clamp SNP6 on Lid of Water Block WAB and Exchange of Dialog iQ Silicone Tubing

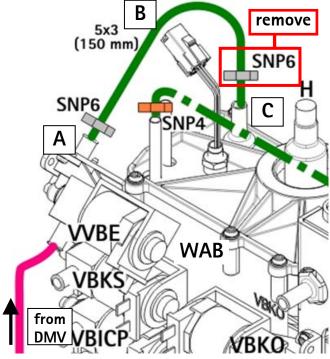
The water inlet silicone tubing at the inlet tank VB on the lid of the water block WAB can slip off from the tubing connector, especially if the central heat disinfection is used.

The pressure pulsation at the water inlet in conjunction with hot incoming water via VVBE (from DMV) can lead to the silicone tubing 5x3 slipping off the tubing connector at the lid of the water block to the inlet tank. The tubing clamp SNP6 at the tubing connector C increases this situation.

1. Turn off Dialog iQ, disconnect water inlet tubing from wall outlet to ensure pressure free water inlet, and open doors.

- 2. Remove both tubing clamps SNP6 at A and C, and then remove silicone tubing B between A and C.
- 3. Replace this silicone tubing by new silicone tubing (5x3, 150 mm length).

Note: Silicone tubing is replaced to ensure a tight seating at tubing connector C. It has to be dry and free of any lubricant.

Note: Do not reconnect the tubing clamp SNP6 at tubing connector C.

- Secure silicone tubing B at A with tubing clamp SNP6.
- 5. Connect water inlet tubing from wall outlet and switch to TSM service program, Low Level Test, 1.9 Water Inlet, Inlet Tank and Flow Pump FPE, to check water inlet part for leakages.
- 6. Close doors and perform a test run in treatment mode with a subsequent disinfection, as described in chapter 5 of the Dialog iQ service manual.
